REPORT NO: NAWCADPAX/TR-2002/94

TESTING CONDUCTED ON WALL-HANGING TROOP SEATS

SUMMARY

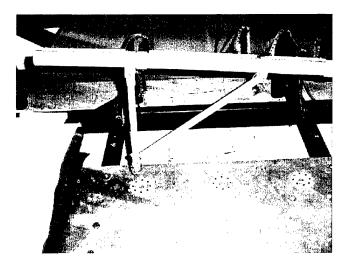
The first test conducted was a back test. Prior to attaching the seat to the Static Test Fixture, the weight of the seat was exactly 5 lb. This test used the three-man pressure foot. The proof load of 1,200 lb was first applied for 60 sec. Prior to reaching the proof load, at approximately 914 lb, the right leg of the seat came free from the bottom plate. Since there was no ripping or failure of the legs or spreader bar, the test continued. Other than the leg coming free, there was no deformation of the seat and no failure. Next, the ultimate load of 1,800 lb was applied. Prior to reaching the ultimate load, at 1,754 lb, the fabric from under the front tube on the left side came free. The fabric did not rip, and the screws did not come loose. The left most tiedown hook came free from the upper attachment, but did not deform or fail. Photographs of the failure are shown in figures 6 through 9. The graph created from the downloaded data is shown below in figure 10. All still photographs that were taken are shown in appendix B.

Figure 6: Right Leg and Distance from Floor Plate

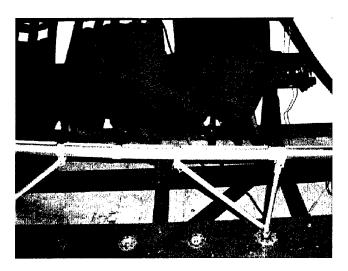
Figure 7: Front of Seat, Showing Fabric Separation from Front Bar

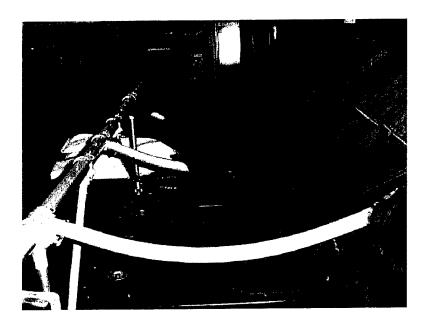
Figure 8: Side of Seat, Showing Fabric Separation from Front Bar

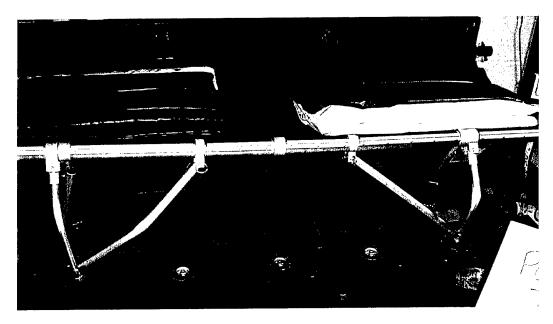
The bottom and side test was the last test conducted. LT Tim Skaar was on hand to witness this test. The seat was weighed prior to testing and weighed 8 lb. The Test Plan called for a proof load for the bottom to be 4,410 lb. The loading was reduced to 4,030 lb to account for the weight of the pressure foot and the weight of the sandbags. This is because the seat would see the total weight of 4,410 lb, while the digital readout would only show 4,030 lb. The bottom load was first applied to the seat and held for 60 sec. After 60 sec, the displacement of the front tubing was measured and the side proof load was calculated to be 450 lb. This load was applied and, when reached, the right spreader bar came loose from the rear bar where it was attached. After consulting with LT Skaar, this was not deemed a failure and the testing continued. After holding the side proof load for 60 sec, the bottom load was increased so that the ultimate load of 6,220 lb could be reached. Prior to reaching the ultimate load at 5,420 lb, the legs of the seat buckled and the left spreader bar came loose from the rear bar where it was attached. It was

determined that the seat no longer had load-bearing capability and the test was stopped. Photographs of the failures are shown below in figures 14 through 19. The graph created from the downloaded data is shown below in figure 20. All still photographs taken are available in appendix B.

Figure 14: Front View of Failure of Legs

The three-man wall-hanging troop seat does not meet the standards established in Military Standard 5804C. Because they do not meet this standard, they do not give adequate protection to the troops that have to sit in them. Therefore, it is recommended that the seat be redesigned or that a replacement for the seat be found.

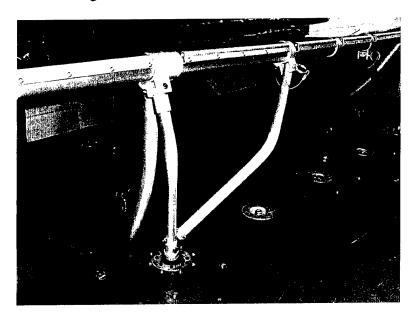
Figure 15: Closeup of Failure of Right Leg

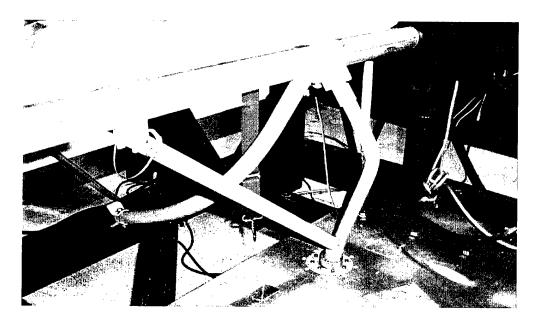
Figure 16: Closeup of Failure of Left Leg

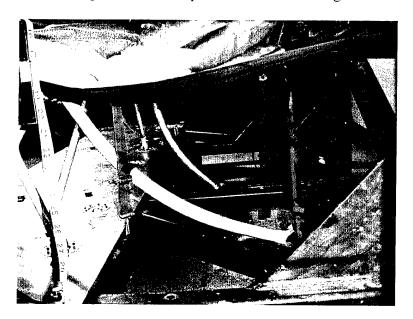
Figure 17: Spreader Bars from Side

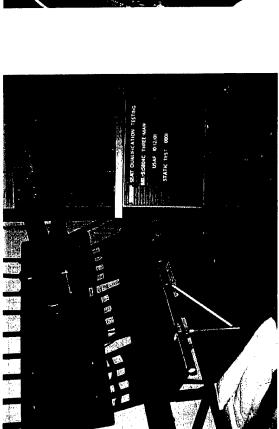
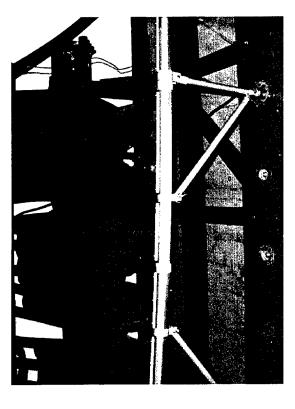
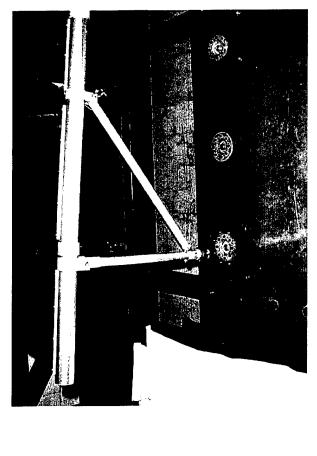
NOTES: At approximately 914 lb, the locking device on the right leg unlocked and allowed the right leg to come out of the fastening point. The leg was 6 in. off the floor plating. At 1,754 lb, the fabric came out from under the seat structure attaching screws. There were no tears or rips anywhere in the fabric. No other damage was done to the seat.
